# Assessment of Estuarine Shoreline Erosion Dynamics as Indicator of Sea-Level Rise Along the South–East Coast of Nigeria

Long-term field investigations to assess shoreline erosion were carried out on a sandy estuarine shoreline of Qua Iboe River estuary, South-East coast of Nigeria. An evaluation of shoreline maps and satellite imageries of 2002, 2013 and 2023 revealed a retrogradation of the estuarine shoreline at the updrift and downdrift estuarine beaches. Two areas of intense erosion at the downdrift estuarine beach which were noted in 2002 have been accreting from 2013 to the present, while on a major erosion site at the updrift estuarine beach noted in 2013 is still eroding to date. Alongshore grain-size pattern depicted very well-sorted fine-grained sand with no significant correlation with the erosion sites. Channel meandering processes in the estuary and low amplitude wave reflections from the shoreline may account for the estuarine shoreline morphodynamics. Erosion occurred around the meandering channel elbow close to the estuarine shoreline while accretion is attributed to the deflection of meandering channel processes away from the shoreline and accentuated by storm s

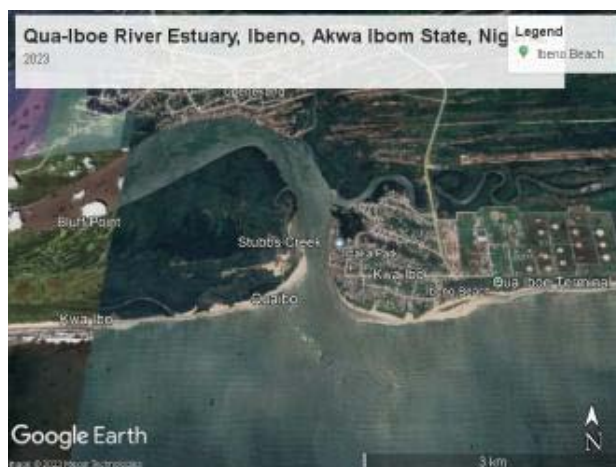
**Plate1:** Google Earth Satellite Imagery of Qua-Iboe River estuary, Ibena, Akwa Ibom State, S.E. coast of Nigeria: Image dated November, 2023

Qua-Iboe River estuary and its adjoining ocean shoreline is located in Ibeno Local Government Area, Akwa Ibom State, along the South-East coast of Nigeria (Plate 1), (Figs.1 and 2). The ocean shoreline is exposed to semi-diurnal tides with tidal range of 2-4m (mesotidal) and south-westerly waves with amplitude less than 200 cm. Modal wave periods close to the shore are 8 to 12s. Current pattern in the estuary is ebb dominated. Maximum flood and ebb velocities are in the ranges of 22 to 33cm/s due north and 113 to 160cm/s southward respectively. Longshore current along the ocean shoreline is predominantly easterly with periodic reversals to the west due to changes in tidal stage. The wind conditions vary annually from calm (November-February) through transitional (February-April) and storm (May-October) periods.

The shoreline was surveyed in 2002 and 2013 with the aid of Global Positioning System (Figs.1-2) and as well as visual observations in 2024 (Plates 2-5) compared with the satellite images up to 2023 (Plate 1). Flood and ebb tidal currents velocities in the estuary were measured at half -hourly intervals over a-12-hour tidal cycle using Langrangian technique.

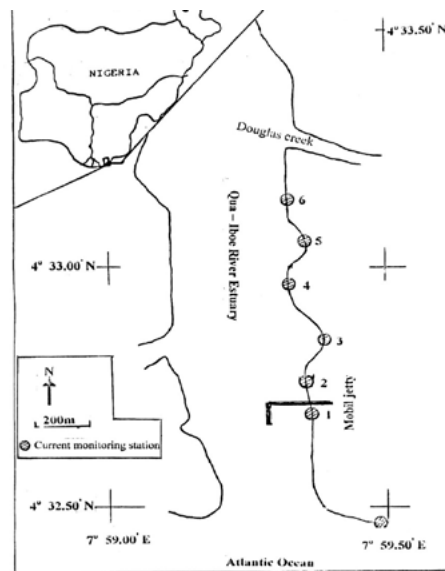
**Figure 1:** Map of Qua-Iboe River estuary, Ibeno, Akwa Ibom State, S.E. coast of Nigeria showing monitoring stations in 2002 (After Udo, 2002).

The shoreline geometry of the estuary mouth in 2022 depicted an estimated width of over 300m while over 400m was estimated for 2024. The estuary however broadened upstream to over 500m wide with increase in distance from the mouth. The eastern flank (downdrift) of the estuarine shoreline showed two major arc-shaped erosion sites with diameters of 250m and 150m respectively at 800m and 1400m upstream of the estuary mouth (Fig.1). This above shoreline erosion was attributed to impact of low amplitude wave reflections at two consecutive elbows of meandering channel thalweg in the estuary.

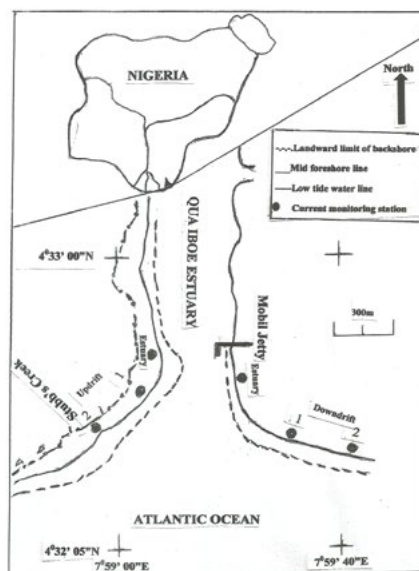
**Figure 2:** Map of Qua-Iboe River estuary, Ibeno, Akwa Ibom State, S.E. coast of Nigeria showing monitoring stations in 2013 (After Udo-Akuaibit, 2013).

showed sediment accretion on the downdrift beach with the two erosion sites filled up with sediment. On the other hand, an erosion site with depression arc diameter of less than 100m was evident at a location of less than 500m off the estuary mouth at the western flank (updrift) of the estuarine beach (Fig.2) (Plate 3a.) in 2013 persisted till date (Plate 3b) while the eastern estuarine shoreline is accreting till date. Moreover, visual observations in 2024 revealed severe threat of erosion in which some of the structures left in 2013 were completely destroyed and lost to the sea with the land retrograded (Plates 4 a and b). Also, the entrance of the tidal channel (Itak-Abasi Creek) which was completely sealed-off by longshore drift in 2013 (Plate 5a) is now completely encroached by *Nypa* palm vegetation (Plate 5b) and the tidal channel deflected landward and meandered away from the shoreline.

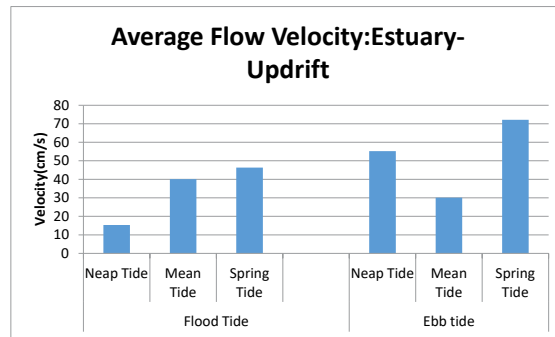
**Figure 3:** Average current flow velocity in the estuary during neap, mean and spring tide during the week of September 28 to October 5, 2013 (Udo-Akuaibit, 2013)

Generally, flow pattern in the estuary at both updrift and downdrift locations showed northward directed flow during flood tide and southward during ebb tide. In summary, 65.80% of current velocities in the estuary were ebb currents with an averaged velocity of 36.56cm/s due south over the flood component during neap tide. Flow pattern during mean tide depicted flood currents dominance with 52.98% of the total flow as well as an averaged flow velocity of 8.29cm/s due north. During spring tide, 54.77% of the total flow velocities in the estuary were ebb currents with an averaged flow velocity of 22.66 cm/s due south against flood currents. Precisely, flow pattern in the estuary is ebb-dominated southward (Fig.3) with meandering channel thalweg (Plates 1 and 2) which also influences erosion of the western flank of the estuary around meandering

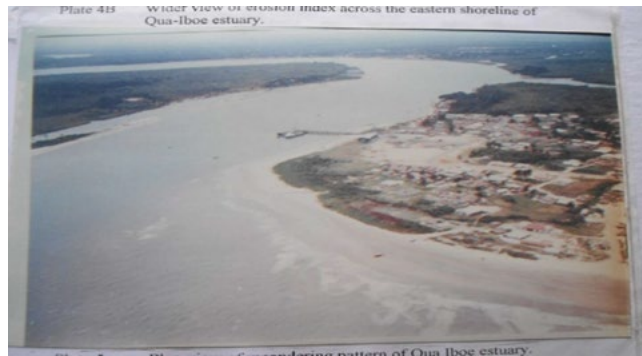
**Plate 2:** Aerial photo of Qua-Iboe River estuary in 2002 (Udo, 2002).

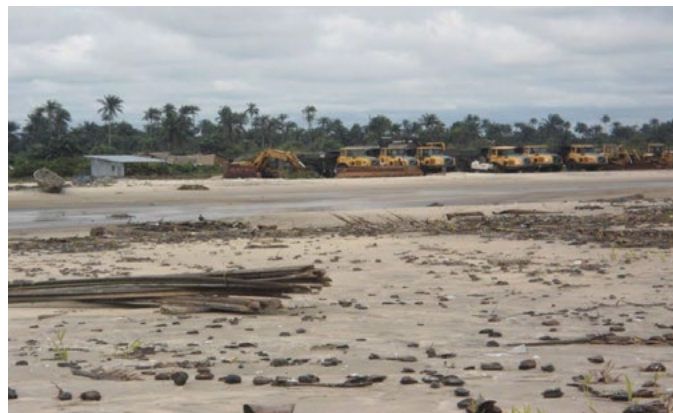
**Plate 3a:** Severe erosion at updrift estuarine shoreline. Photo: September 28, 2013 (Udo-Akuaibit, 2013).

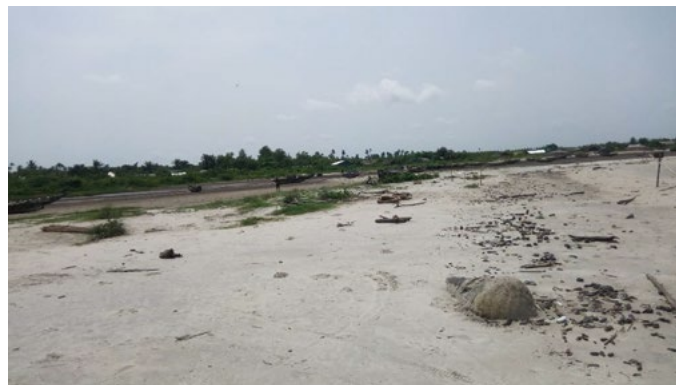
**Plate 3b:** Severe erosion at updrift estuarine shoreline. Photo: March 17, 2024.

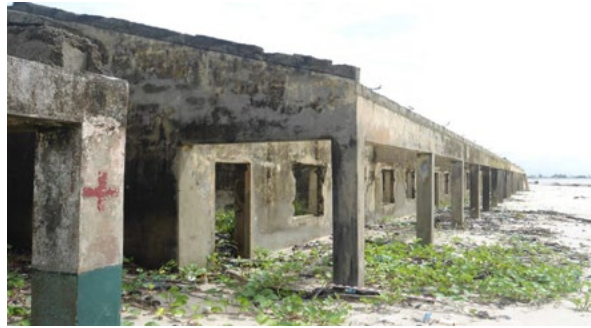
**Plate 4a:** Former ItakAbasi Primary School located at updrift shoreline damaged by storm surge incident in 2011. Photo: September 28, 2013 (Udo-Akuaibit, 2013).

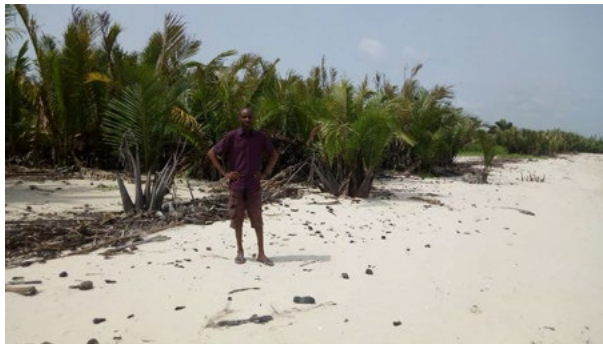
**Plate 4b:** Recent location of former Itak Abasi Primary School at the updrift shoreline now encroached by Nypa palm vegetation. Photo: March 17, 2024.

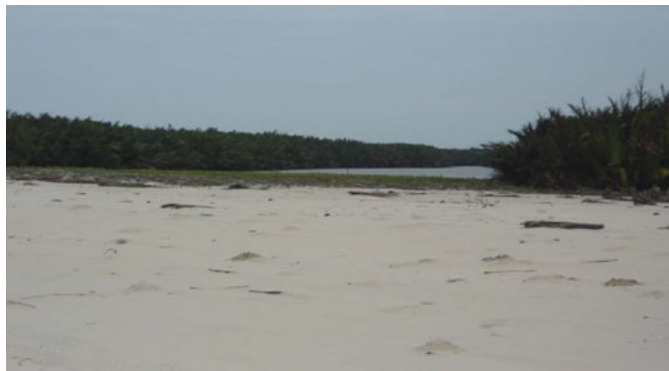
**Figure 5a:** Entrance of Itak-Abasi creek sealed-off by longshore drift due to storm surge incidence at the updrift shoreline in 2011. Photo: September 28, 2013 (Udo-Akuaibit, 2013).

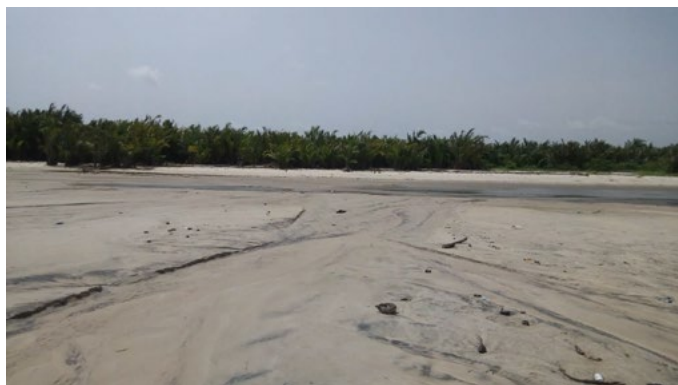
**Figure 5b:** Recent location of former Itak-Absi creek entrance encroached by Nypa Palm vegetation. Photo: March 17, 2024.
