# Nanostructure Self-Organization as Cause of Wavelike Radiation Embrittlement of the RPV Steel

E.A. KRASIKOV\*

National Research Centre "Kurchatov Institute", Kurchatov Sq., 1, Moscow 123182, Russia

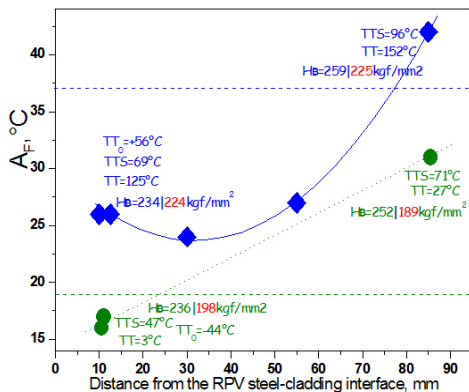
The unexpected results of the icebreaker RPV weld and base metal studying are given in Figure 1, where one can recognize that the actual (measured) radiation embrittlement coefficients of the trepan materials for the periphery (remote) zone of the vessel are significantly higher that for the inner part. One can see also that hardness measurement and Charpy impact testing results agree.

**Figure 1:** Radiation embrittlement coefficient  $A_F$  and hardness value HB through the icebreaker RPV wall distribution. TT – transition temperature,  $TT_0$  – transition temperature in initial state. Note:  $H_B = 252|189\text{kgf/mm}^2$  – hardness values at as-received condition|after annealing 650°C/2h.

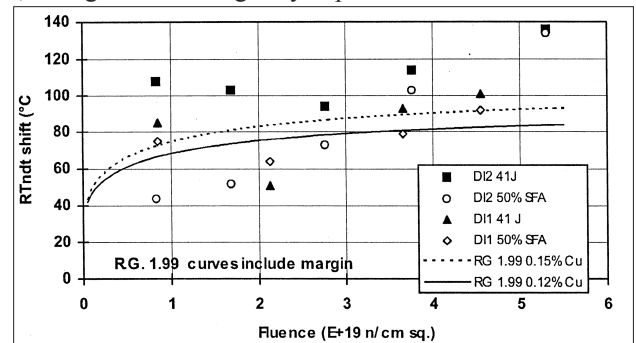
Search of similar far from trivial effect brings to example where it characterized by authors as «quite atypical» for Doel I, II weld metal SS data (Figure 2) [2]. One can recognize that relatively to Regulatory Guide 1.99 curves zones with opposite effects take place, enlarged shift changes by depressed one.

**Figure 2:** Doel I, II weld - surveillance results.

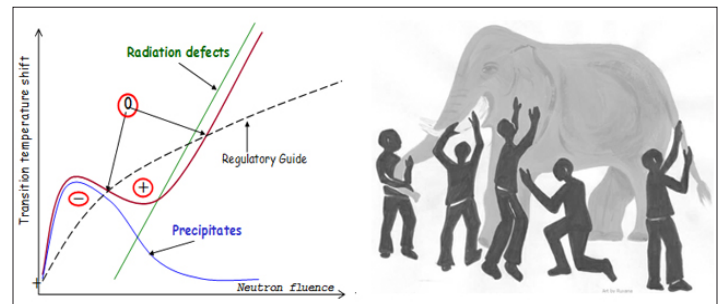
Summing the previously mentioned on the subject discussed one might conclude, that depending of the fluence level reached manifestation of the «flux effect» in reference to Guide pattern may be quite different, namely: negative, positive and «two zeros» as represented in (Figure 3). Situation looks like famous parable «blind men and an elephant», where a group of blind men (or men in the dark) touch an elephant to learn what it is like. The story is used to indicate that reality may be viewed differently depending upon one’s perspective, suggesting that what seems an absolute truth may be relative due to the deceptive nature of half-truths.

**Figure 3:** Sketch of the flux effect manifestation. Blind men and an elephant

In accordance with sketch of Figure 3 flux effects manifestation depends on fluence level. At low fluencies radiation degradation has to exceed normative value, then approaches to normative meaning and finally became sub normative. As a result of dose rate effect manifestation peripheral RPV's zones in some range of fluencies have to be damaged to a large extent than situated closely to core.

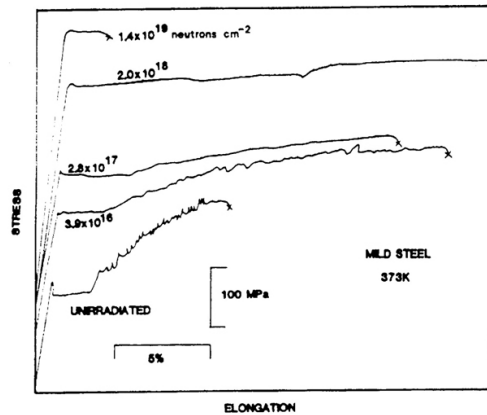
curve monotony character damage. The very wonderful fact is the enhanced degradation aftereffect of the temporary weakening of the embrittlement appearance. Possible comprehensible explanation is as follows: the radiation-induced copper-rich precipitates nature (dimensions and concentration) alteration. Evidently, we have fixed phenomenon similar to observed in where neutron irradiation in some range of doses improves the mechanical properties of the unirradiated mild steel (**Figure 4**) [4].

It is seen that irradiation of unirradiated (initial condition) steel up to dose of  $\sim 2,0 \times 10^{18} \text{ cm}^{-2}$  along with strengthening lead to more than 2-fold ductility increase.
